INVESTIGATION REPORT

HOTEL FIRE  
GREECE, NEW YORK  
TEN FATALITIES  
NOVEMBER 26, 1978

DAVID P. DEMERS  
FIRE ANALYSIS SPECIALIST  
FIRE INVESTIGATIONS DEPARTMENT

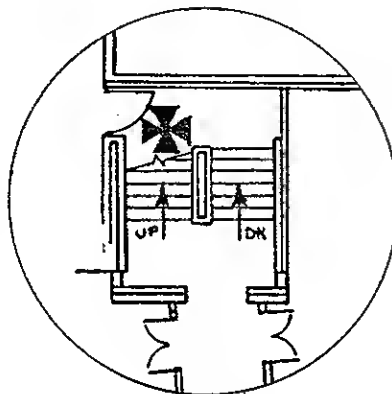
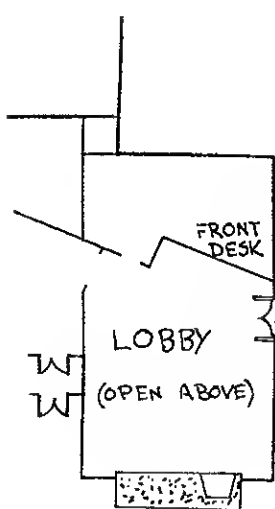
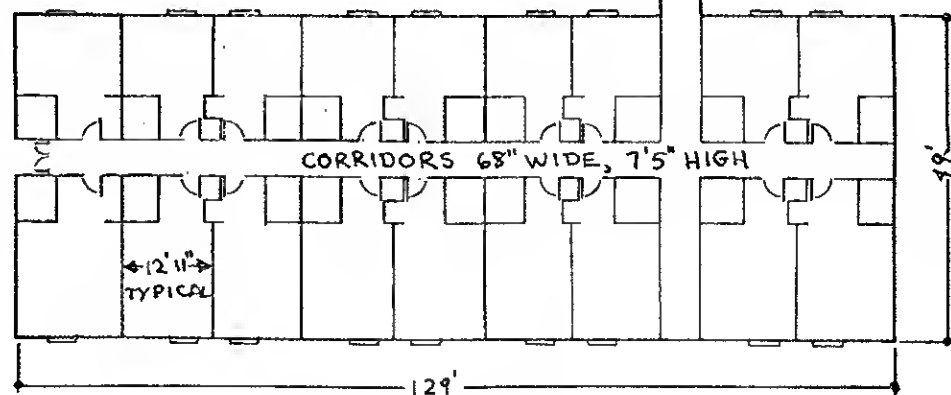
FIRST FLOOR		FIG. 2
	DATE	DRAWN BY	
	2-12-79	DWD

COMBUSTIBLE  
CLOSET ON GROUND  
FLOOR UNDER STAIRS

APPROXIMATE AREA OF  
ORIGIN ON GROUND FLOOR

† FATALITIES, 2 WERE DOA  
AND CAME FROM UNKNOWN  
LOCATIONS  
10 FATALITIES TOTAL

--> INITIAL FIRE SPREAD  
OUT OF CENTRAL STAIRWAY
